Attachment P - Falmouth Maintenance Yard

VDOT MS4 (General Permit No. VAR04)
Falmouth Area Headquarters
VDOT District No. 6

Facility Name: Falmouth Area Headquarters
Location: 1007 Thomas Lane, Fredericksburg, VA, 22405
Latitude: N 38.336771* **Longitude** W 77.488015*

Date of Visit: October 22, 2012
Entry Time: 2:00 p.m. (approx)
Exit Time: 4:15 p.m. (approx)

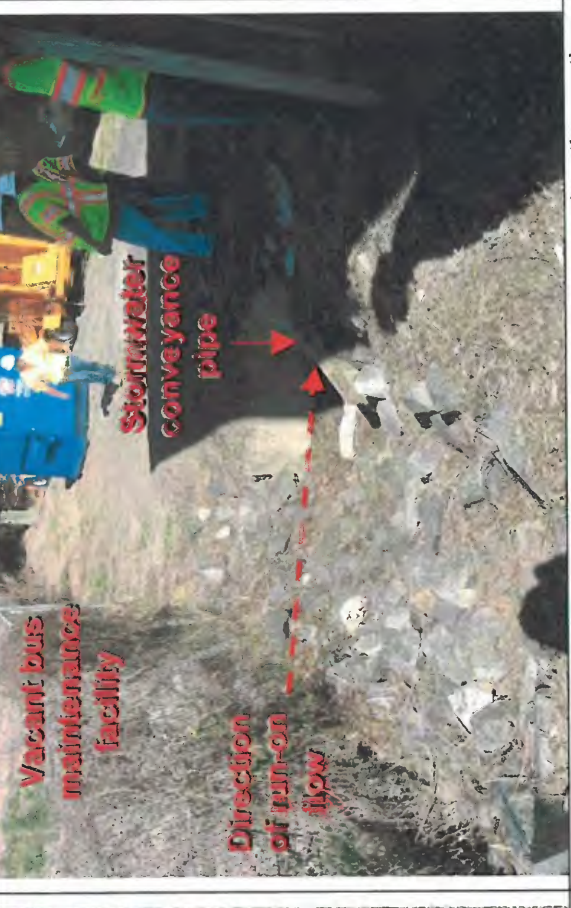
2. The VDOT Facility TOM II explained that visual stormwater observations are conducted at the Facility after storm events because a vacant bus maintenance facility to the west conveys oily storm water onto the Facility in the central-west portion of the site (see Photographs 2 and 3). In addition, VDOT provided inspection records in the VDOT Response Inventory (see VDOT Response Inventory Item No. 44.B) for an annual housekeeping inspection that occurred at the Facility on May 24, 2012.

<div>Photograph 2 – View facing north of a stormwater run-on location on the west side of the Facility.</div>

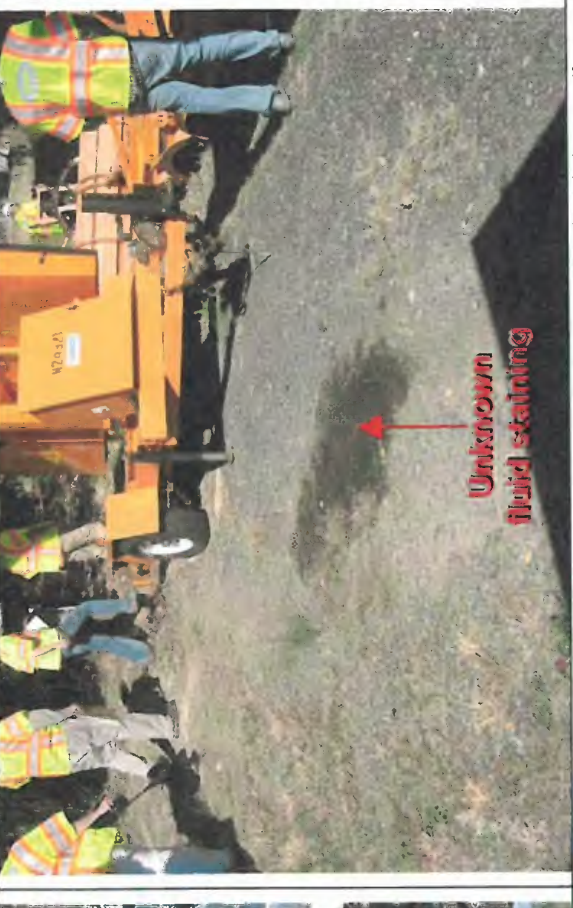
4. Visible staining from an unknown fluid was observed on the pervious ground surface in the northwestern portion of the facility, adjacent to the Facility solid waste disposal dumpster (see Photograph 4).

<div>Photograph 4 – View facing north of an unknown fluid staining on the ground surface in the northwest portion of the Facility.</div>

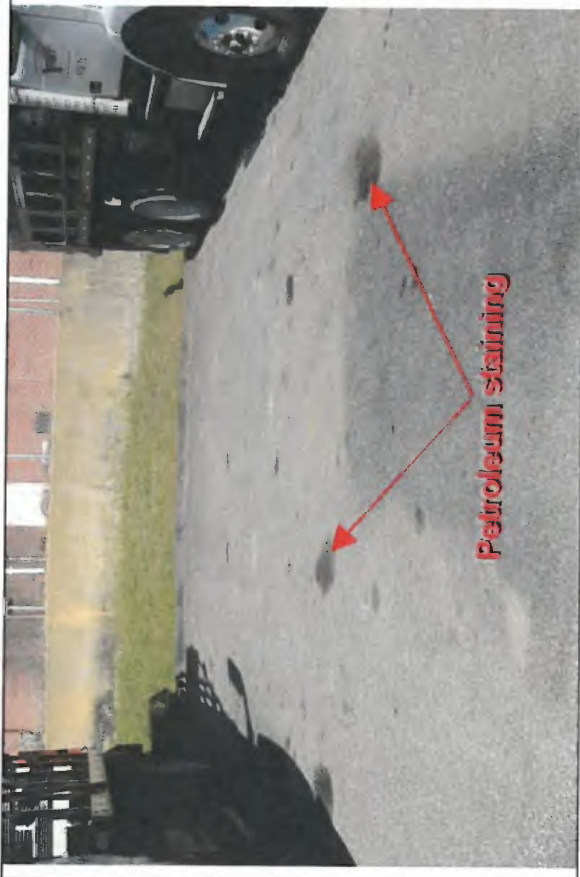
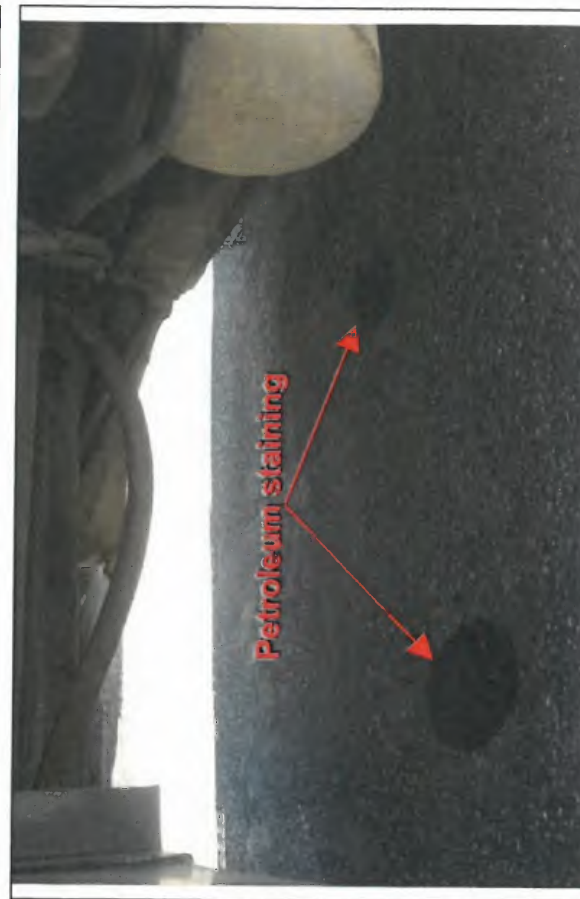
5. Visible petroleum staining was observed on the impervious surface in the north-central portion of the Facility in the vehicle/equipment parking area (see Photographs 5 and 6). The staining was located upgradient of two Facility storm drain inlets, which convey stormwater runoff to the stormwater basin and to the on-site salt pond (see Photograph 7).

<div>Photograph 5 – View facing north of petroleum staining on the impervious surface in the north-central portion of the Facility.</div>	<div>Photograph 6 – Close-up view of recent petroleum staining on the impervious surface underneath a vehicle in the north-central portion of the Facility.</div>

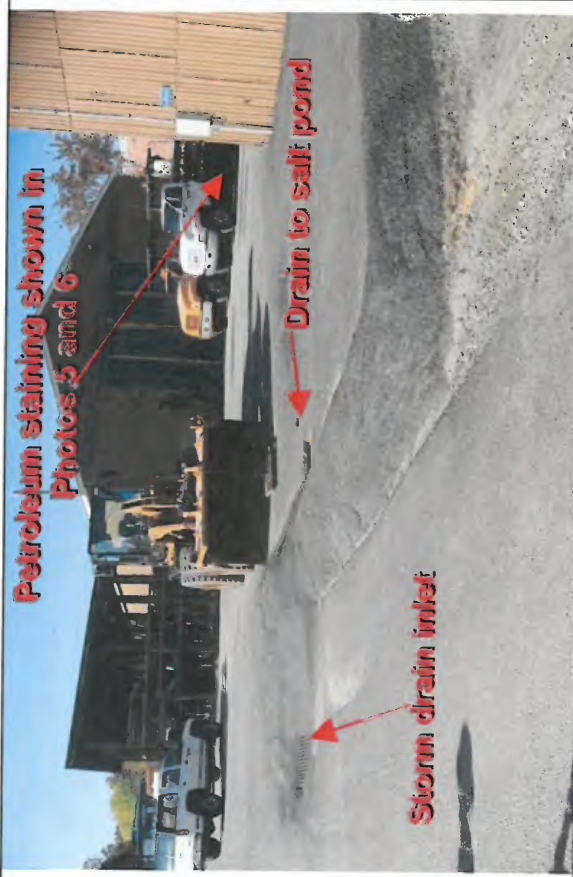
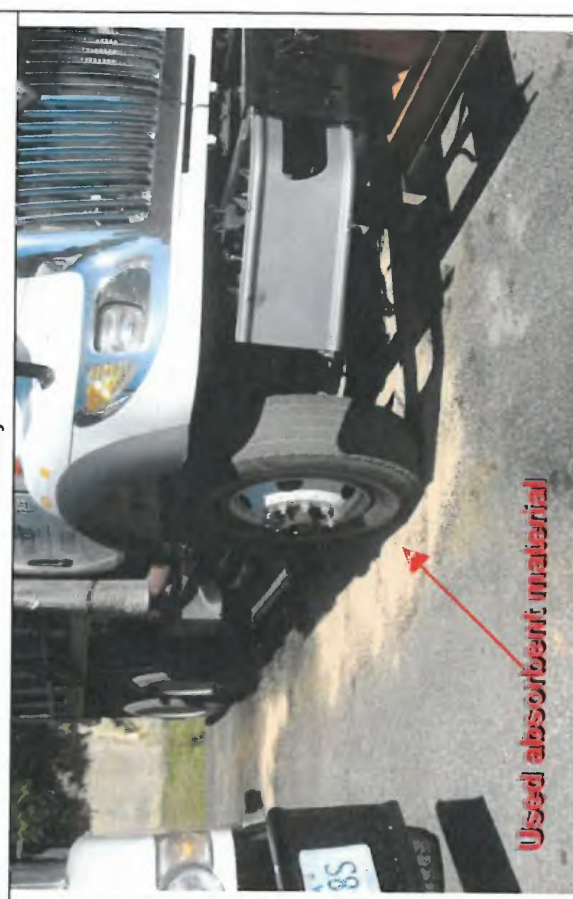
6. Multiple vehicles in the central and north-central portion of the Facility were observed with recent spills and/or leaks of unknown fluids underneath, on the impervious surface. Absorbent materials had been implemented to clean the spills and/or leaks; however, the absorbent material had not been disposed of after use (see Photographs 8 and 9). One vehicle was observed with staining underneath; however, absorbent material had not been placed on the spill/leak. Facility staff explained that they had run out of absorbent material.

<div>Photograph 7 – View facing northwest of storm drain/salt pond drain inlets located downgradient from petroleum staining shown in Photos 5 and 6.</div>	<div>Photograph 8 – View facing northeast of absorbent material implemented in the north-central portion of the Facility.</div>

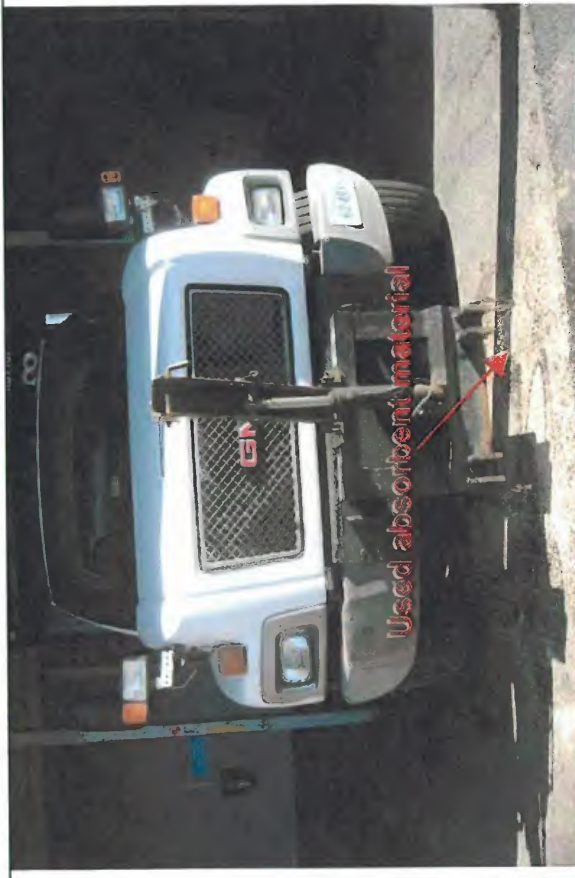
Photograph 9 – View facing east of absorbent material implemented in the central portion of the Facility.

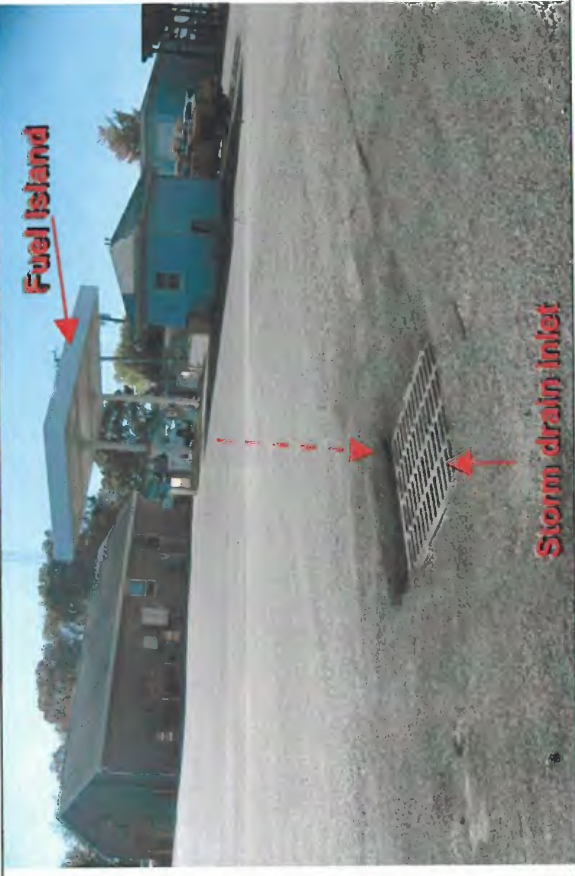
7. A storm drain inlet was observed downgradient from the Facility fuel island, in the central portion of the Facility. VDOT Facility staff did not have procedures for bulk fuel unloading, fuel vendors, or routine fueling of vehicles/equipment. In addition, containment measures leaks or spills were not evident (see Photographs 10 and 11).

Photograph 10 – View facing southwest of an unprotected storm drain inlet located downgradient from the Facility fuel Island. Note the Island did not have containment measures implemented.

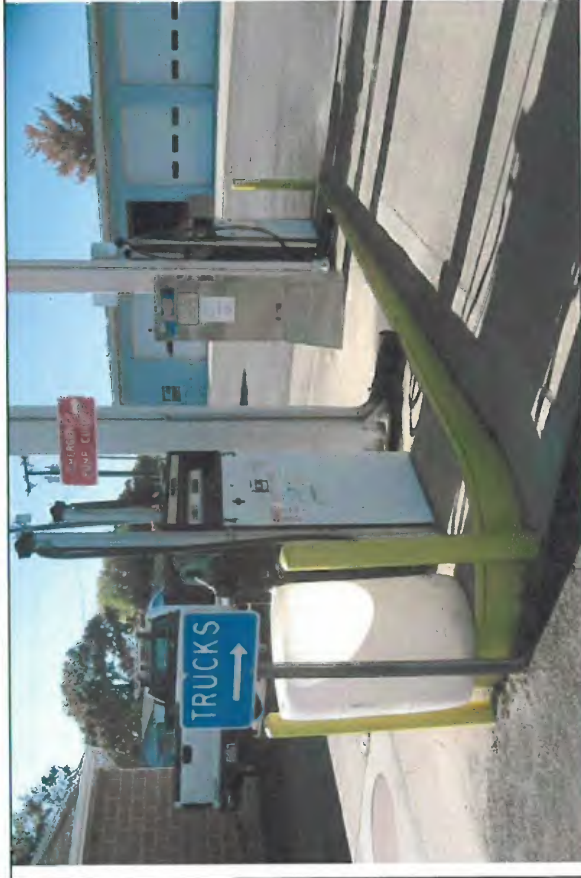
Photograph 11— Close-up of the Facility fuel Island shown in Photo 10. Note the fuel Island did not have containment measures implemented.

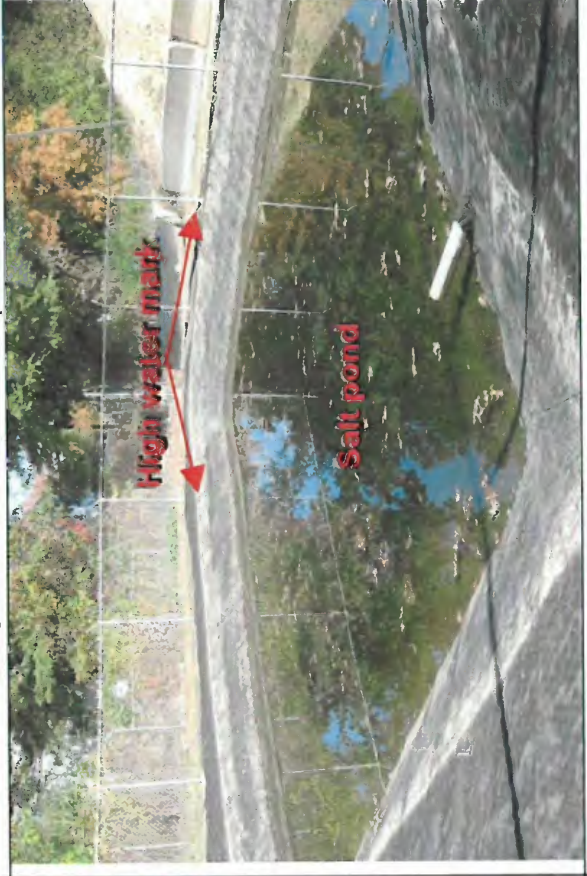
8. A salt pond located in the northeastern portion of the Facility was observed with high water marks inches below the freeboard capacity (see Photograph 12). The EPA Inspection Team noted concern that the containment pond, if not inspected and emptied prior to large rain events, had the ability to overflow into the stormwater basin (see Photograph 16). The storm water basin drains into a riser structure at the end of the channel, and subsequently discharges through an outfall into a drainage channel on the east side of Old Forge Drive (see Photographs 17 and 18).

Photograph 12— View facing northeast of the Facility salt pond located in the northeast portion of the Facility.

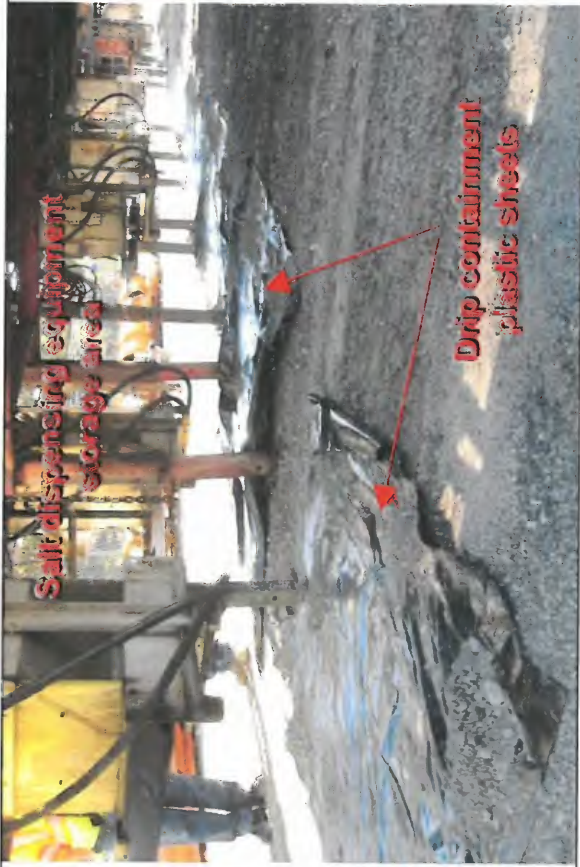
9. Drip containment plastic sheets were observed implemented under the Facility's salt dispensing equipment on the eastern side of the Facility (see Photograph 13). According to Facility representatives, the plastic sheets were recently installed.

10. A storm drain inlet located on the eastern side of the Facility, within a pervious area and adjacent to a sand pile, was observed with a gabion basket implemented for inlet protection (see Photograph 14). Facility staff stated that this gabion basket had been in place for two weeks. The EPA Inspection Team expressed concern that this particular BMP would not be effective in preventing sand and aggregate from entering the storm drain inlet. In addition, an unknown staining was present on the ground surface adjacent to the inlet (see Photograph 15).

<p>Salt dispensing equipment storage area</p> <p>Drip containment plastic sheets</p> <p>Photograph 13 – View facing south of drip containment plastic sheets implemented underneath the Facility salt dispensing equipment.</p>	  <p>Salt pond</p> <p>Sand stockpile</p> <p>Storm drain inlet</p> <p>Photograph 14 – View facing north of a sand stockpile located adjacent to a storm drain inlet.</p>
	  <p>Storm drain inlet protection gabbion basket structure</p> <p>Unknown staining</p> <p>Photograph 15 – Close-up view of an unknown stain adjacent to a protected storm drain inlet.</p>

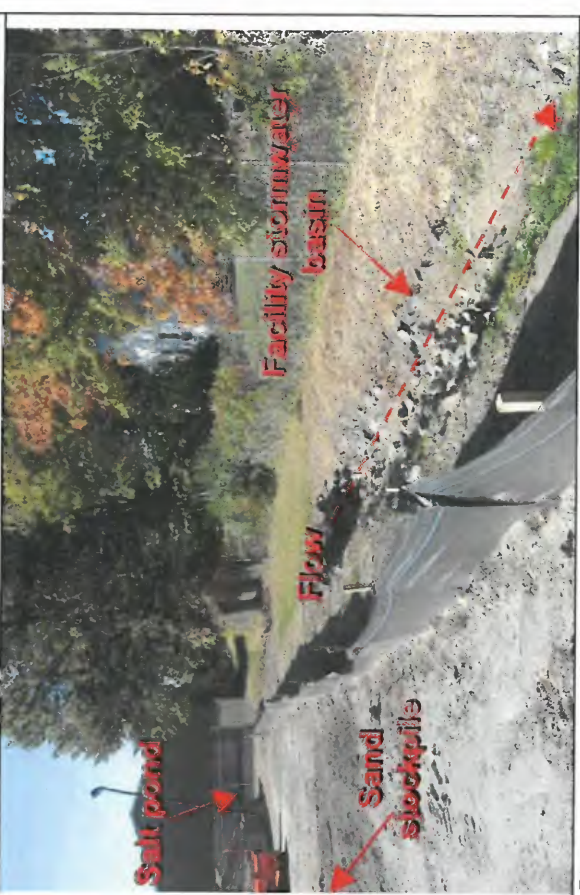
<p>Salt pond</p> <p>Sand stockpile</p> <p>Flow</p> <p>Facility stormwater basin</p> <p>Photograph 16 – View facing northwest of the stormwater basin on the east side of the Facility, along the northern perimeter. This channel conveys all Facility stormwater runoff.</p>

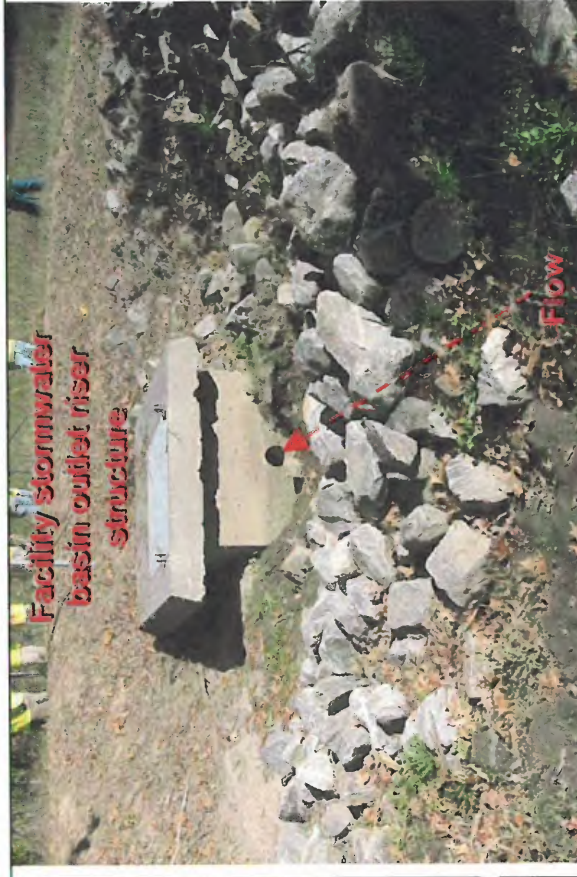
Photograph 17 – View facing east of the Facility stormwater basin outlet riser structure, in the eastern corner of the Facility.

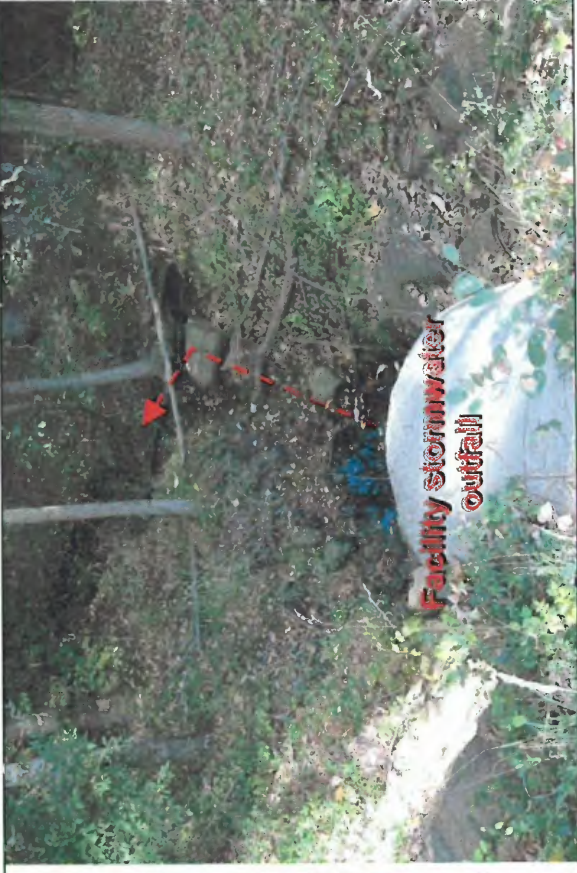
Photograph 18 – View facing east of the Facility stormwater outfall, on the east side of Old Forge Drive.
